DRESSER NO. 1 DAM  
WASHINGTON COUNTY, MISSOURI  
MO 31117

**PHASE I INSPECTION REPORT  
NATIONAL DAM SAFETY PROGRAM**

DRESSER NO. 1 DAM  
WASHINGTON COUNTY, MISSOURI

PHASE I INSPECTION REPORT  
NATIONAL DAM SAFETY PROGRAM

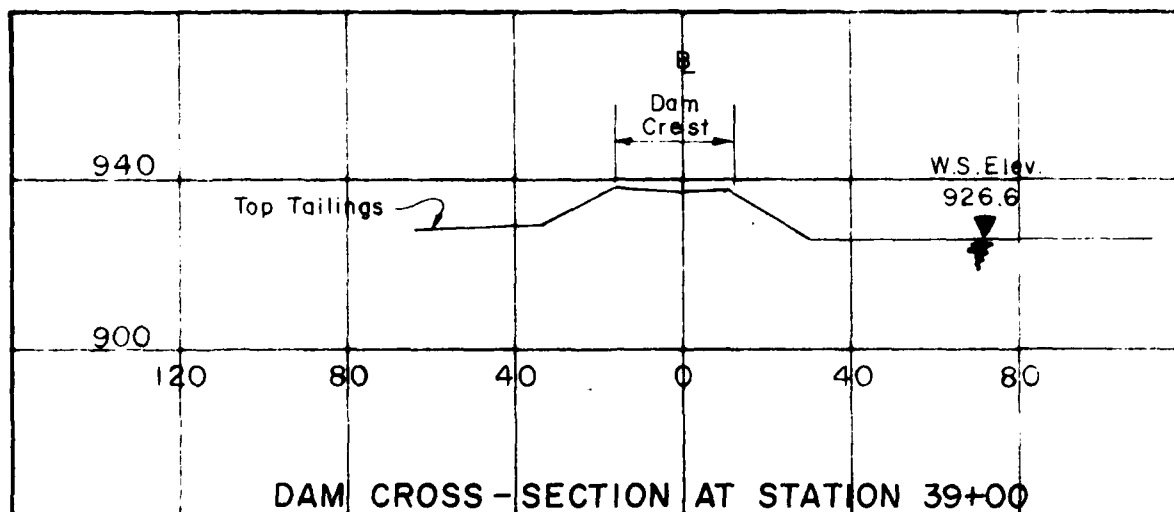
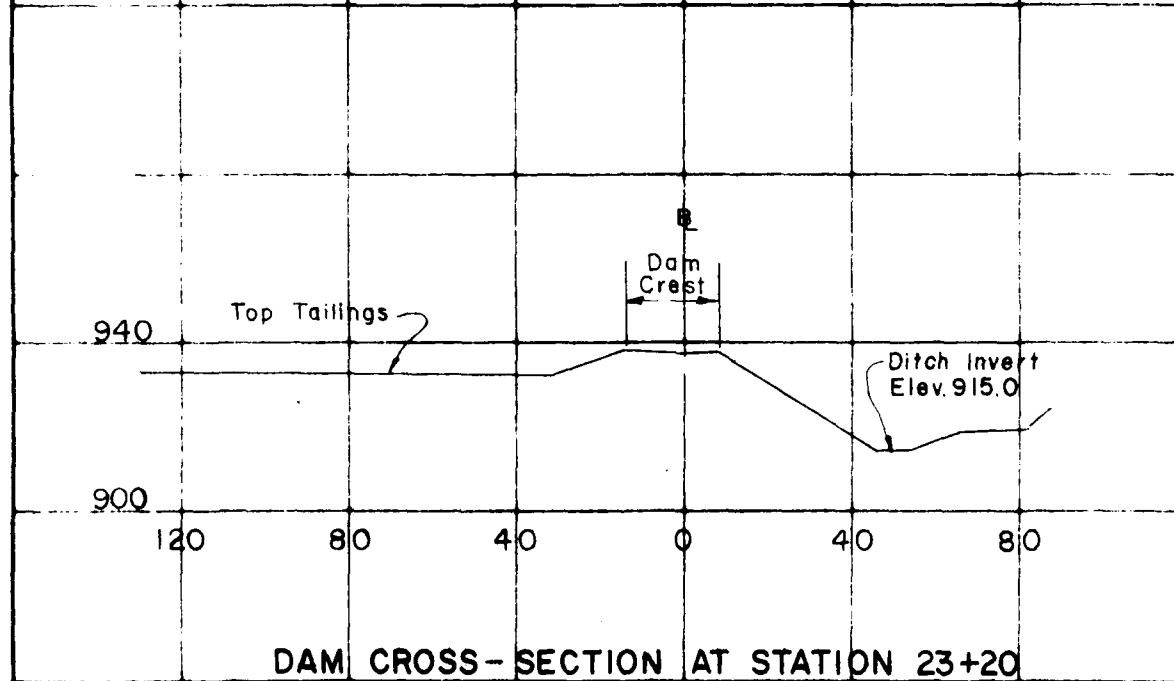
DAM I.D. NO. 31117  
DRESSER NO. 1  
DAM CROSS-SECTIONS  
PLATE 5A

j. Diversion Ditches. A diversion ditch is located along the north side of the impoundment adjacent to the downstream toe of the dam. The ditch conducts runoff impounded in the upstream pond located at the west end of the impoundment to the downstream pond located at the east end of the impoundment. The diversion ditch is V-shaped to U-shaped, about 6 to 8 feet deep and about 1800 feet long. A cross-section of this ditch at Station 23+20 is shown in Plate 5A.
